Flood disaster mitigation concept of settlements in Sario watershed area

Windy J Mononimbar

Urban and Regional Planning Study Program, Sam Ratulangi University

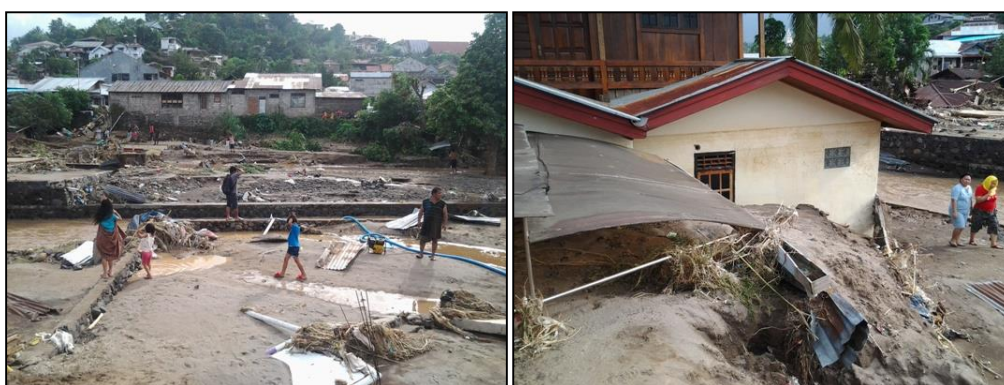
Figure 2. The condition of settlements after flash flood in 2014

surrounding, causing so many losses, both material and non-material losses. One of the areas that experienced the worst impact was the settlement area around the Sario watershed in Wanea District, with the details affected by the flood were 11.030 inhabitants and 1.382 houses destroyed. In fact there was one neighborhood in the Ranotana WeruSub District (Wanea District) whose entire house was lost or washed away by flash floods. Not only that, there were even fatalities washed away in this watershed area.

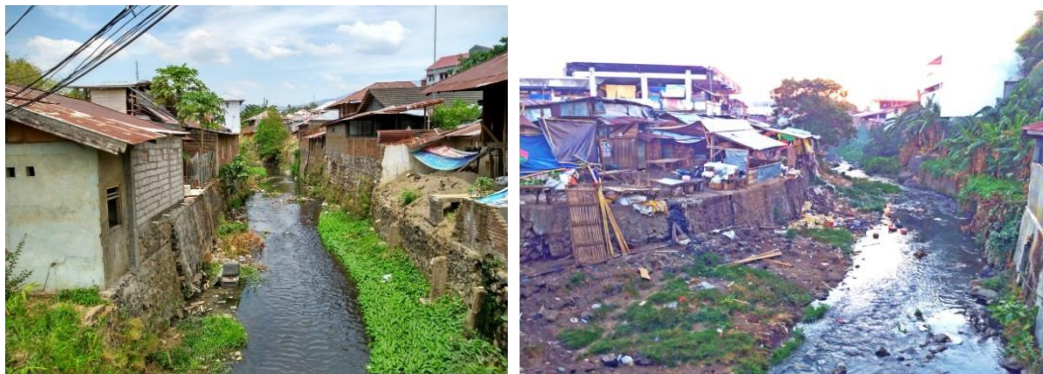
Figure 6. The condition of embankment and river border area in Pinasungkulan Market dan Ranotana Weru Sub District (Segment 1 & 2)

- *The embankment.* After flash flood in 2014, the government has built embankments at some parts with a height of around 2-6.5 meters and the material of concrete rebound. In general the embankment conditions are good but there are still some parts that have not been built or repaired, especially in Segments 1 and 2.
- *Drainage channels.* In general,

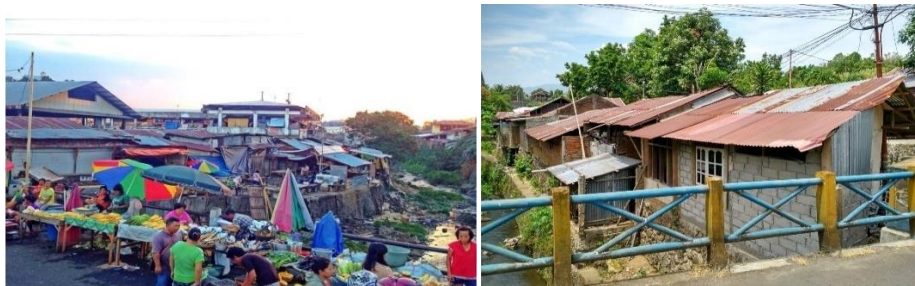
Figure 7. Buildings conditions

- *Structure and Construction.* Overall, the structure and construction of buildings in this area is in ratio of 60:40 (permanent: non permanent), where non-permanent buildings are mostly found in Segment 1 and 2. This leads to non/semi permanent buildings around the river border at high risk of being damaged or washed away by floods.
